# **Fatigue of Composite Material Beam Elements Representative of Wind Turbine Blade Substructure**

John F. Mandell, Daniel D. Samborsky,  
David W. Combs, M. Ethan Scott,  
Douglas S. Cairns  
*Department of Chemical Engineering  
Montana State University  
Bozeman, Montana*

November 1998

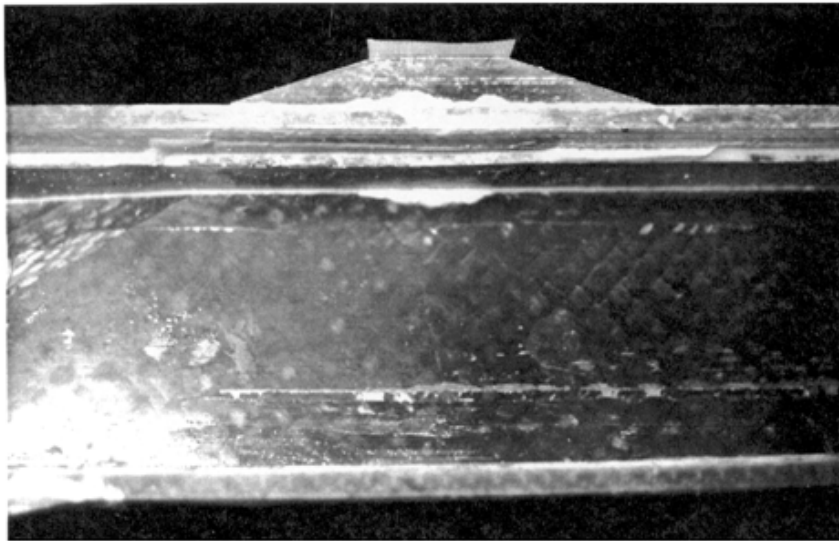
Beam 1 failed with massive damage in the shear web, separation of the outer flange from the flanges of the C-channels, and growth of the compression damage zone under the load pad. We hypothesized that the initial compression damage was a nucleation site for crack growth in the adhesive joint between the outer flange and the flanges of the C-channel. Under cycling, cracks extended, releasing the tension flange from the C-channel flanges and the next stroke of the piston crushed the shear web.

Beam 2 was manufactured and tested to judge the validity of this hypothesis. We terminated the testing of beam 2 before failure because of the growth of damage zones on the tension side flange at the center of both support pads. After dissecting beam 2 we determined that the aforementioned damage was failure of the tension flange-to-web adhesive joint. Visual inspection revealed a smooth fracture surface, which is indicative of an adhesive-line failure as opposed to a rough fracture surface. The latter would have indicated matrix damage (see Figure 12(b)). Therefore, the original hypothesis was incorrect: beam 1 failed because of adhesive failure at the interface of the flanges.

**Figure 12. (a) Load pad damage and compression damage zone, tension side of Beam 1.  
(b) Adhesive failure of Beam 2.**

The adhesive failure of beams 1 and 2 called for a redesign of the beam. The deflection equation for four-point bending (Equation 7) revealed that reducing the value  $I_{zz}$  of the beam by a factor of  $n$  allows for a reduction of the load by the same factor to achieve the same deflection. Also recall that  $\epsilon = f(k, y)$ , i.e., for a given curvature/deflection, the strain is a linear function of  $y$ .  $I_{zz}$  was reduced by narrowing the flange width from 76 mm to 51 mm (now equal to the flange width of the

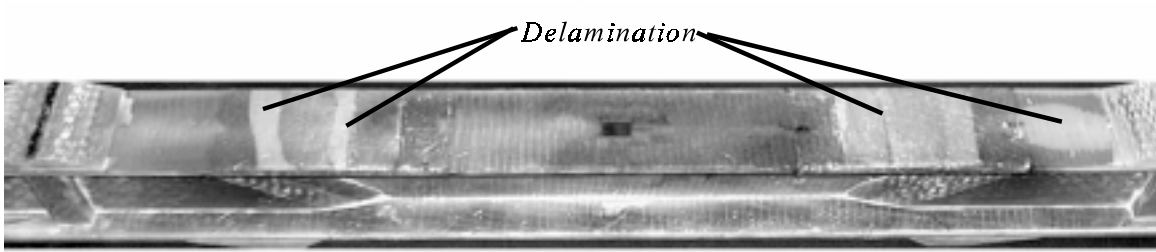
**Figure 27. Accumulated damage on inner surface of tension flange,  $\pm 45^\circ$  plies, 2.26 million cycles, beam 4.**

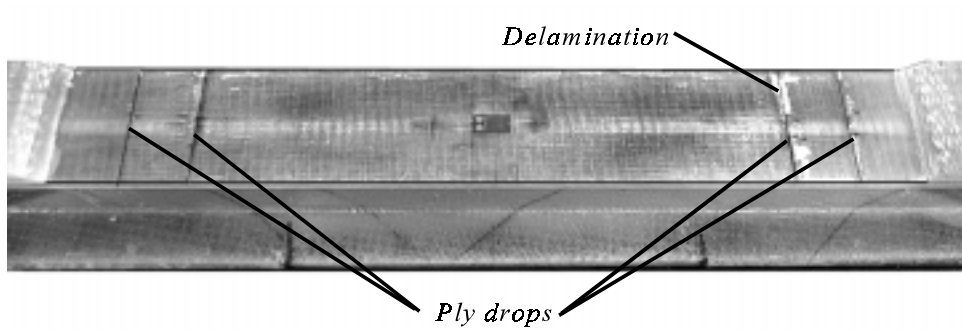
**Figure 28. Outer surface of compression flange, 2.26 million cycles, beam 4.**

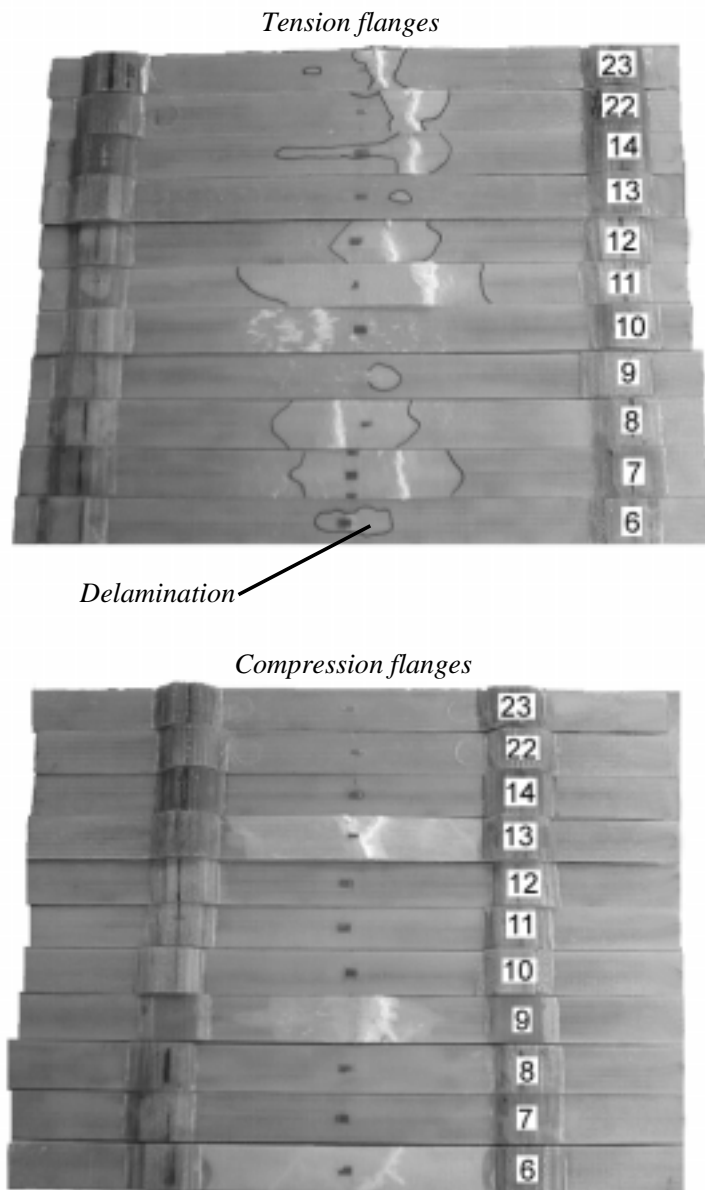
**Figure 32. Tensile and compressive flanges of failed beams with material AA flanges and material CH10 webs.**

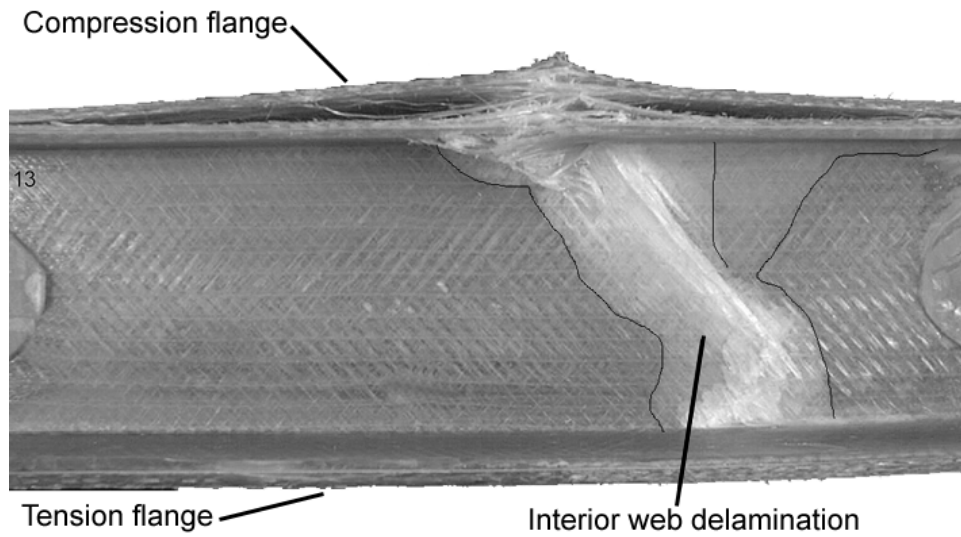
**Figure 33(a). Beam 13 static compression flange failure.**

Beam 13 involved a static test. The beam was loaded under actuator displacement control at a rate of 0.51 mm/s until failure, which involved a total ramp time of 21 seconds. An initial beam stiffness of 3,516 kN/m was measured. The ultimate load was 60.72 kN and corresponded to a maximum tension flange strain of 2.10%, a minimum compression strain of -1.85% and a maximum mid-span deflection of 17 mm. The load versus maximum strain graph is shown in Figure 80. The beam failed in the compression flange at  $x = 330 \pm 25$  mm with delaminations between the 0° (ply 10, Table 22) and +45 plies (ply 11, 22) over the distance of  $x = 165$  mm to  $x = 457$  mm. The failed beam is shown in Figures 81 and 82. The failure at  $x = 330$  mm caused the web to delaminate towards the tension flange under this failure point, causing an additional delamination spot under the tension flange. No shear stiffener, torsional stiffener or other tension flange damage or delaminations were visible.

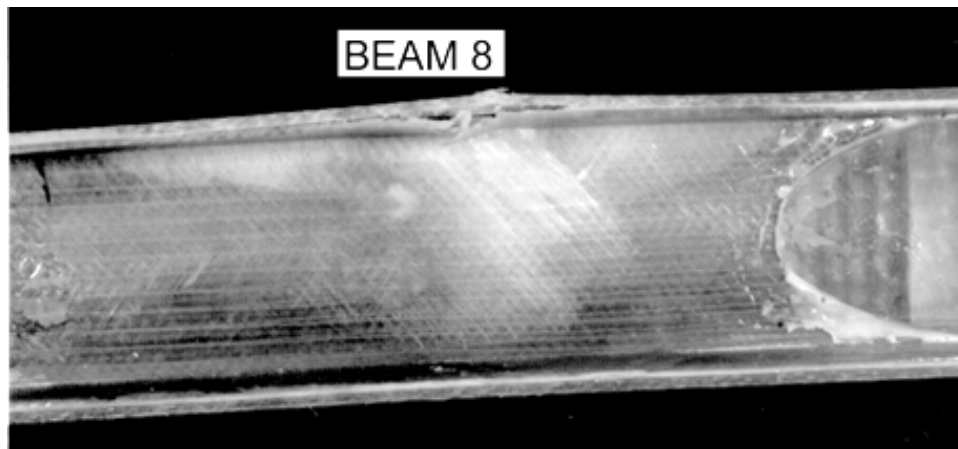
**Figure 33(b). Beam 8 tension flange failure.**

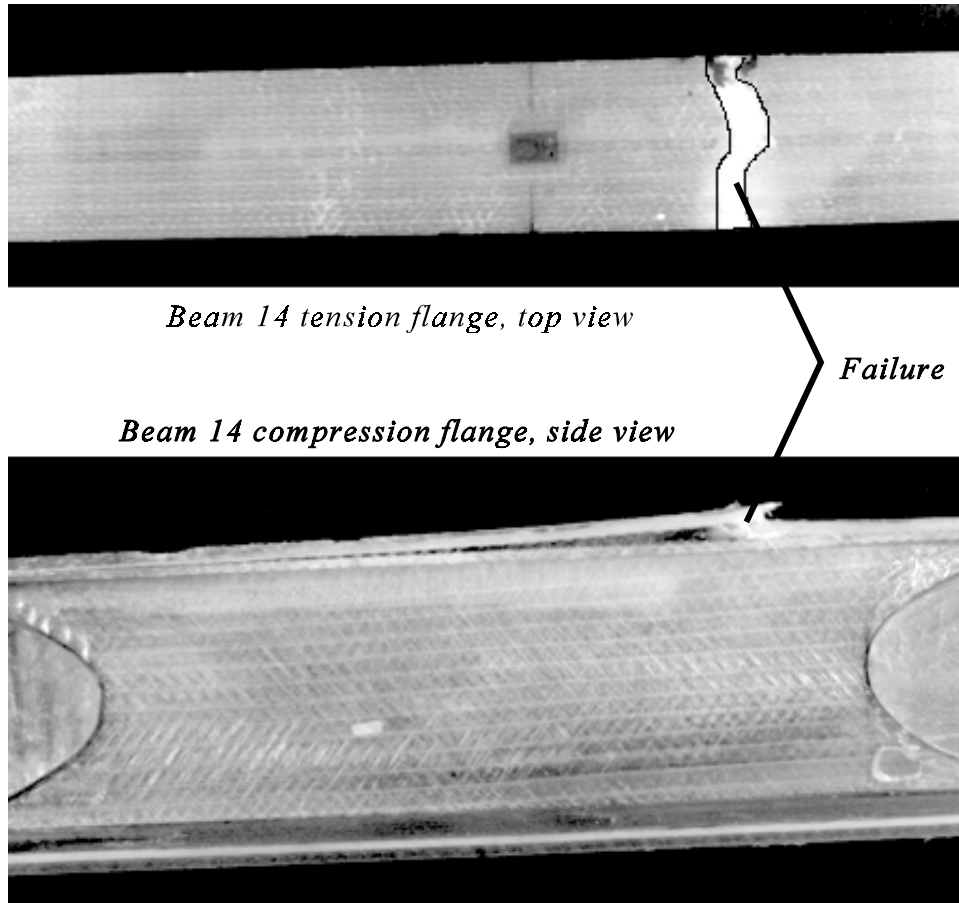
**Figure 33(c). Beam 14 tension flange fatigue failure.**

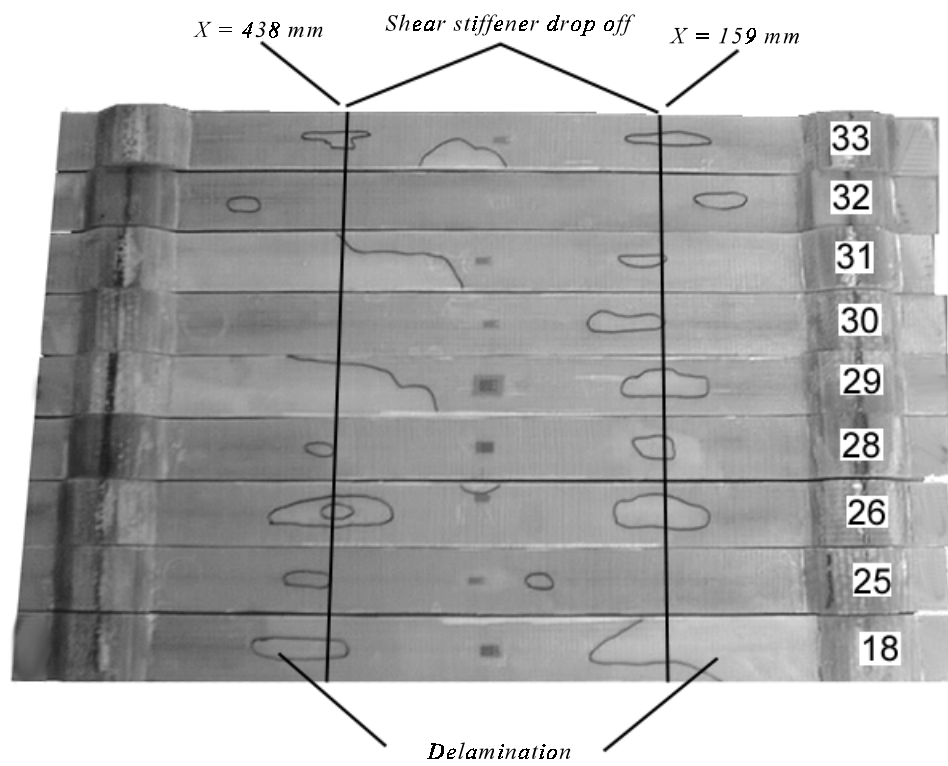
**Figure 36. Tension flanges of failed beams with material DD5P flanges and material CH3 webs.**

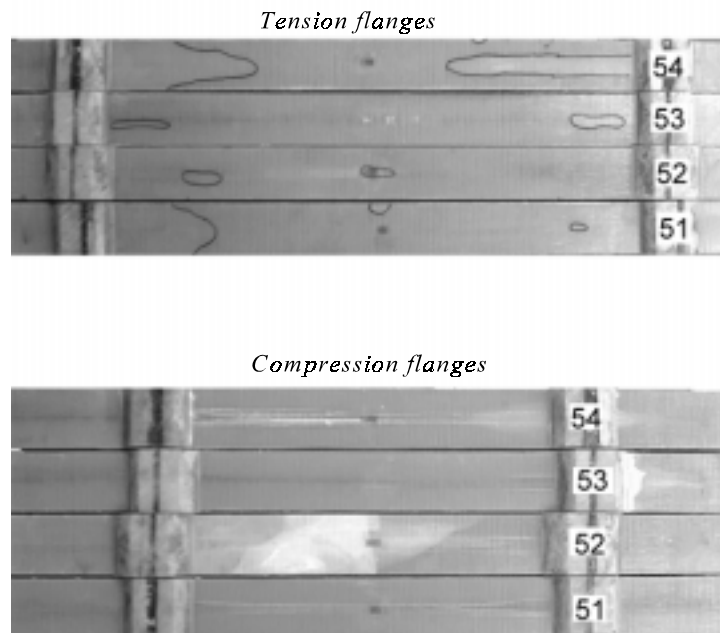
**Figure 41(b). Tension and compression flanges of failed beams with material DD5P flanges and webs.**

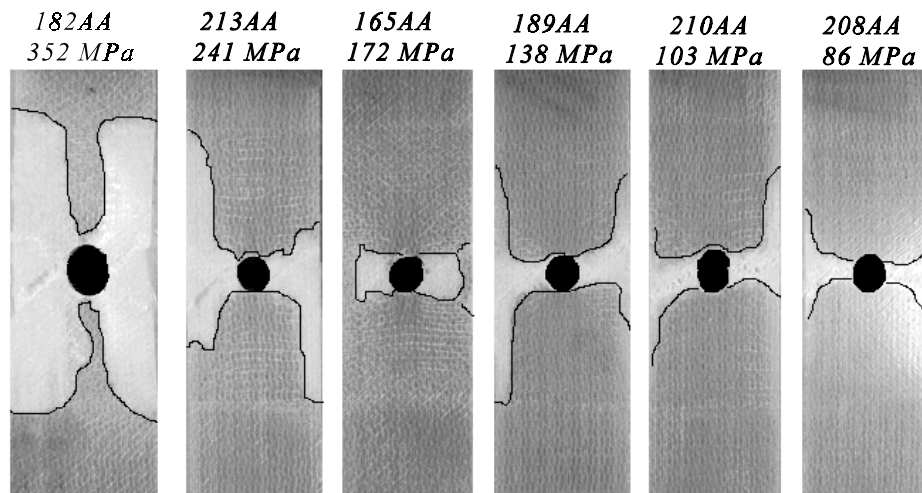
**Figure 45. Photograph of damage around the 13 mm diameter hole at different stress levels,  $R = 0.1$ .**

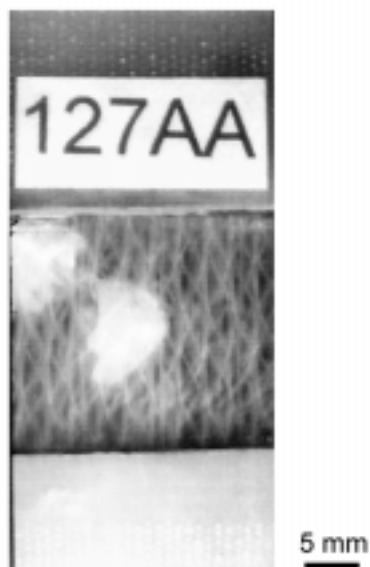
**Figure 46. Delamination on a compression fatigue coupon.**

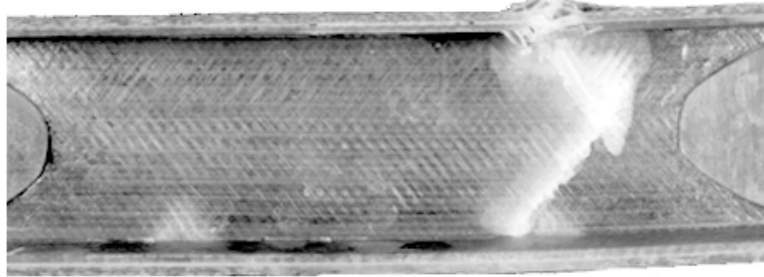
**Figure 48. Beam 15 with holes, static compression flange failure.**

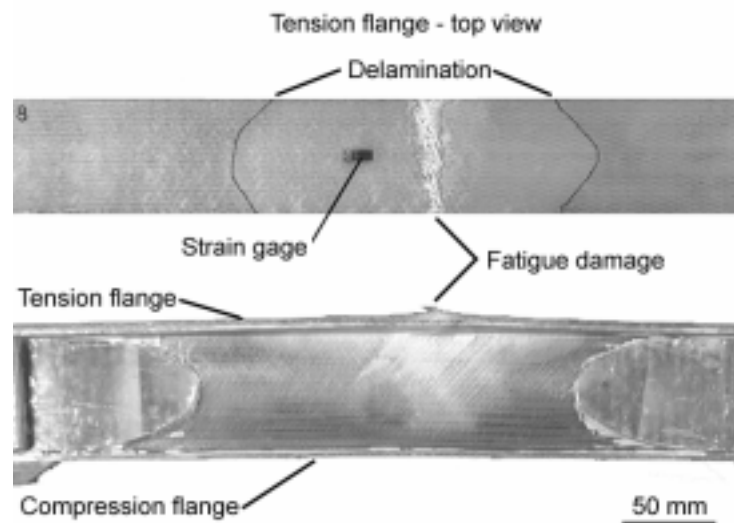
**Figure 68. Beam 8.**

At 29,051 cycles, the tensile flange failed and separated at  $x = 324 \pm 9$  mm, which caused the flange to delaminate from the preform between  $x = 255$  to  $x = 368$  mm and is shown in Figures 68 and 69. The delamination involved extensive fiber bridging between the inside flange  $+45^\circ$  (ply 12, Table 22) and the adhesive on the preform. This beam was fatigued at a higher strain than Beam 7 and thus had more internal strain energy stored in it prior to failure, which is apparent by the amount of damage generated in the web as compared to Beam 7. The web delamination extended 45 mm from the tension flange and was located at  $x = 324 \pm 44$  mm. No shear stiffener, torsional stiffener or compression flange damage or delaminations were visible.

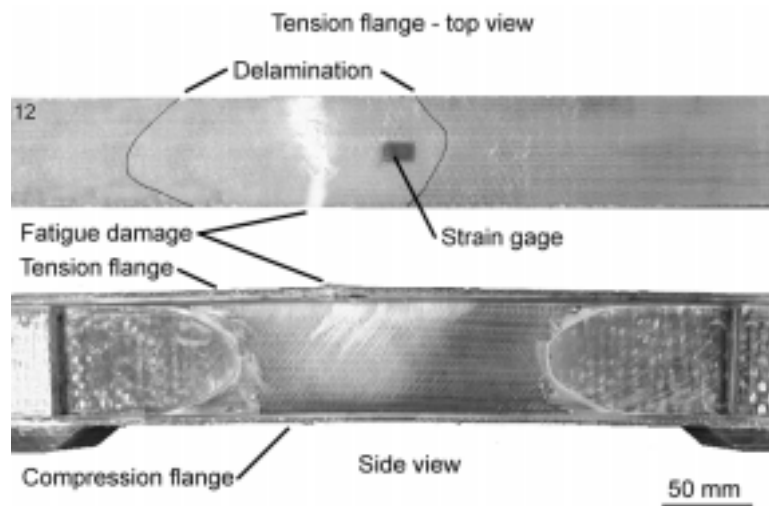
**Figure 79. Beam 12.**

The final failure site started at one edge of the flange and grew to the other edge. After 30,290 cycles, the beam failed on the tension flange at  $x = 336$  mm and is shown in Figure 79. The flange delaminated between the adhesive and the  $+45^\circ$  ply (ply 12, Table 22) from  $x = 279$  to  $x = 394$  mm and contained multiple fiber bridging sites. The tension flange delamination traveled 45 mm into the web directly under the failure site. Some other minor cracks were evident on the flanges of the preform as the  $\pm 45^\circ$  fabrics did not completely fill the C-channel mold, and thus created a matrix rich region on the flange edge, which cracked and segmented. These cracks were on the order of 10 mm in length, 5 mm wide and were located over the shear stiffener area of the beam. The load pads showed the same minor delamination problem as in Beam 11. Both these manufacturing flaws did not seem to cause any problems with the performance of the beam during the test. Otherwise, no shear stiffener, torsional stiffener or compression flange damage or delaminations were visible.

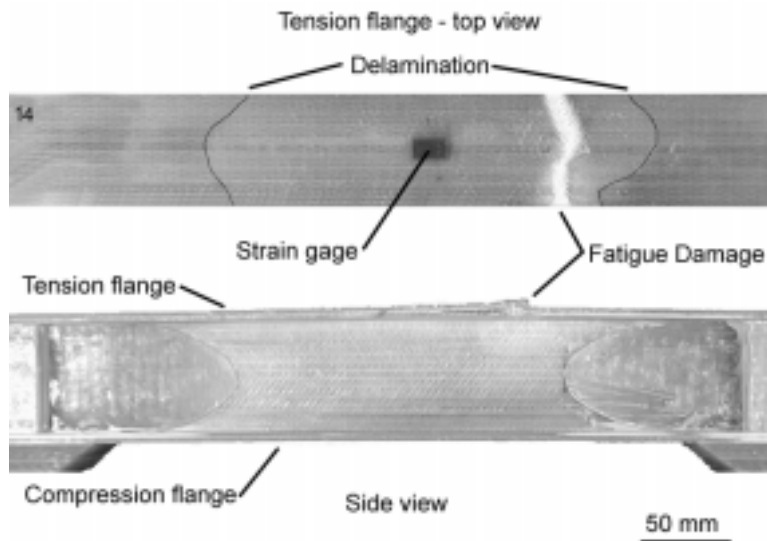
**Figure 83. Beam 14.**

Beam number 14 was fatigued at a rate of 5 to 10 Hz with a maximum load of 24.5 kN and a minimum load of 2.5 kN. The maximum load produced an initial maximum tension flange strain of 0.59% and a minimum compression flange strain of -0.58%. The initial beam stiffness was measured as 3,407 kN/m. The fatigue test was stopped after 160,000 cycles to check the stiffness, which had reduced to 3,271 kN/m or 96% of the initial stiffness. After 389,175 cycles the tension flange failed at  $x = 248 \pm 6$  mm. The damage started at the edge of the flange and grew across the flange until final failure. The failure caused a delamination from  $x = 229$  mm to  $x = 394$  mm and was between the  $+45^\circ$  ply (ply 16, 22) and the  $-45^\circ$  ply (ply 17, Table 22) in the web flange. Figure 83 shows the failed beam. This delamination extended 10 mm down into the web. No shear stiffener, torsional stiffener or compressive flange damage or delaminations were visible.

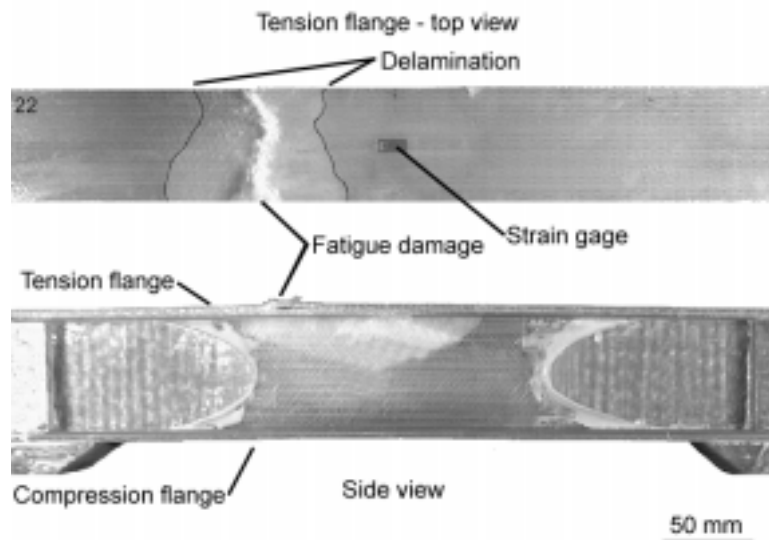
Figure 84. Beam 22.

Beam number 22 was fatigued at a rate of 5 Hz with a maximum load of 31.1 kN and a minimum load of 3.1 kN. The maximum load produced an initial maximum tension flange strain of 0.84% and a minimum compression flange strain of -0.76%. The initial beam stiffness was measured as 3,637 kN/m. This beam had two acoustic emission sensors on the tension flange centered at  $x = 70$  and 543 mm and two on the compression flange centered at  $x = 178$  and 432 mm. The acoustic emission testing was performed with Dr. Al Beattie from Sandia National Laboratory. This beam showed less white damage sites on the tension flange than the previous beams during the fatigue test. Final failure occurred on the tension flange at  $x = 368 \pm 10$  mm with a delamination between the  $+45^\circ$  ply (ply 11, Table 22) and the  $-45^\circ$  ply (ply 12, Table 22). The delamination was between  $x = 330$  and 406 mm and grew 25 mm into the web. The failed beam is shown in Figure 84. No shear stiffener, torsional stiffener or compression flange damage or delaminations were visible.

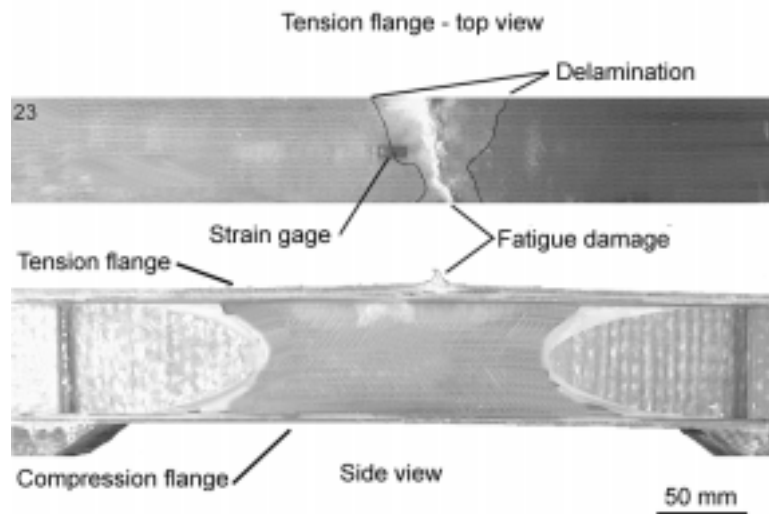
Figure 85. Beam 23.

Beam number 23 was fatigued at a rate of 5 Hz with a maximum load of 28.9 kN and a minimum load of 2.9 kN. The maximum load produced an initial maximum tension flange strain of 0.71% and a minimum compression flange strain of -0.64%. The initial beam stiffness was measured as 3,542 kN/m. This beam also had two acoustic emission sensors on the tension flange centered at  $x = 64$  and 543 mm and two on the compression flange centered at  $x = 178$  and 438 mm. The beam failed in the tensile flange after 119,995 cycles. The failure site was at  $x = 318 \pm 10$  mm and created a delamination between the adhesive and the  $+45^\circ$  ply (ply 13, 22) of the preform from  $x = 292$  to  $x = 356$  mm. This delamination extended 18 mm down into the web. The web flange had a matrix rich region on the edge of the flange between  $x = 279$  and  $x = 470$  mm and had a maximum depth towards the web of 8 mm. The failed beam is shown in Figure 85. The failure site of the tensile flange was within this matrix rich region and it is believed that the initial delamination was nucleated at this edge and between the adhesive and the preform. Although this beam went 89,705 cycles longer than Beam 12, it is assumed that this had some minor effect on the performance of the test, but not a large enough effect to be considered a structurally flawed beam. No shear stiffener, torsional stiffener or compression flange damage or delaminations were visible.

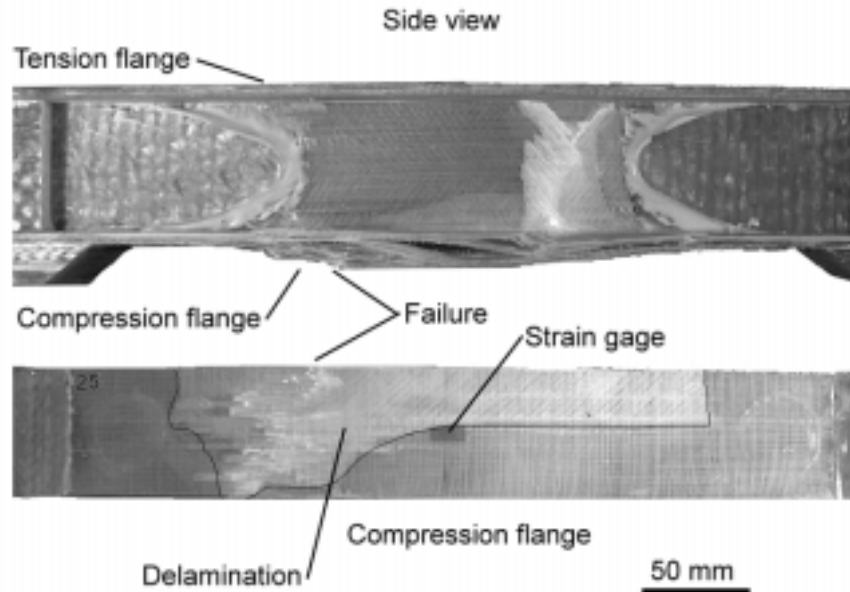
**Figure 93. Beam 25.**

Beam number 25 was fatigued at a rate of 2 Hz under sinusoidal load control with a maximum load of 62.3 kN and a minimum load of 6.2 kN. The maximum load produced an initial maximum tension flange strain of 1.43% and a minimum compression flange strain of -1.13%. The initial beam stiffness was measured as 4,305 kN/m. The beam had four acoustic emission sensors on the flanges: two on the tension flange centered at  $x = 63$  and  $533$  mm, and two on the compression flange centered at  $x = 170$  and  $430$  mm. After 7,636 cycles, the compression flange failed at  $x = 229 \pm 13$  mm. A loud pop was heard one cycle prior to failure and it is suspected that a partial delamination grew to a point where it compromised the stability of the compression flange, lowering the strength of the beam to below the maximum fatigue stress. The final failure of the beam indicates a twisting of the compression flange at failure. The flange delamination extended from  $x = 170$  to  $432$  mm and involved all the  $0^\circ$  to  $45^\circ$  interfaces and the adhesive layer. The delamination traveled into the web towards the tension flange and created two spot delaminations. Transverse tension cracks were also present on the tension flange over the web. It is not known if these transverse cracks were present prior to flange failure. No shear stiffener, torsional stiffener or other tension flange damage or delaminations were visible. The failed beam is shown in Figure 93.

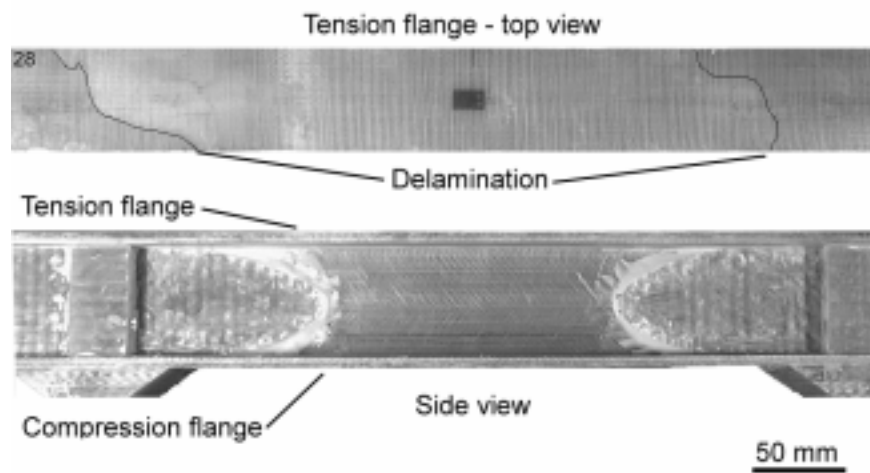
**Figure 96. Beam 28.**

Beam number 28 was fatigued at a rate of 5 to 12 Hz under sinusoidal load control with a maximum load of 44.5 kN and a minimum load of 4.4 kN. The maximum load produced an initial maximum tension flange strain of 0.86% and a minimum compression flange strain of -0.85%. The initial beam stiffness was measured as 4,142 kN/m. Tension flange delamination spots started to develop over the tapered shear stiffener area,  $x = 178$  and  $445$  mm, after approximately 600,000 cycles. After 2,000,000 cycles, the beam was stopped and the only damage present was the delamination between the tension flange and the adhesive layer. This is shown in Figure 96. The compression flange has two transverse tension cracks,  $x = 406$  to  $445$  mm extending under the load pad. No shear stiffener, torsional stiffener or other flange damage or delaminations were visible.

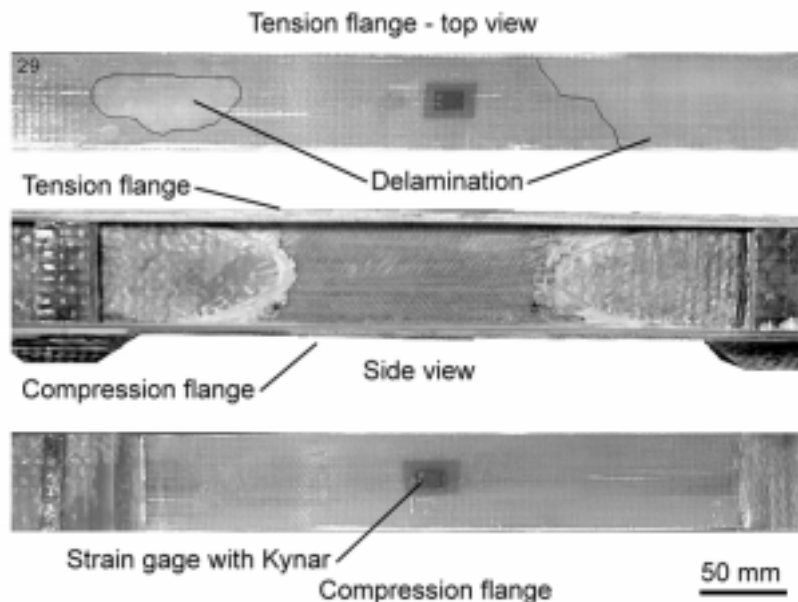
**Figure 97. Beam 29.**

Beam number 29 was fatigued at a rate of 4 Hz under sinusoidal load control with a maximum load of 48.9 kN and a minimum load of 4.9 kN. The maximum load produced an initial maximum tension flange strain of 0.92% and a minimum compression flange strain of -0.96%. The initial beam stiffness was measured as 4,100 kN/m. Kapton film was placed between the strain gages and the flanges in hopes of preventing the matrix cracks from traveling into the strain gages. The traveling was not stopped and the gages failed after 4,000 cycles. No significant improvement in strain gage lifetime, with the Kapton film, was observed. The beam was stopped after 815,684 cycles prior to beam failure. At this point the tension flange delamination extended between the  $0^\circ$  ply (ply 5, Table 24) and the  $-45^\circ$  ply (ply 6, Table 4),  $x = 0$  to 115 mm, and between the adhesive and the  $0^\circ$  ply (ply 8, Table 24),  $x = 115$  to 260 mm. The compression flange showed three small transverse tensile cracks but otherwise no other damage. The beam is shown in Figure 97.

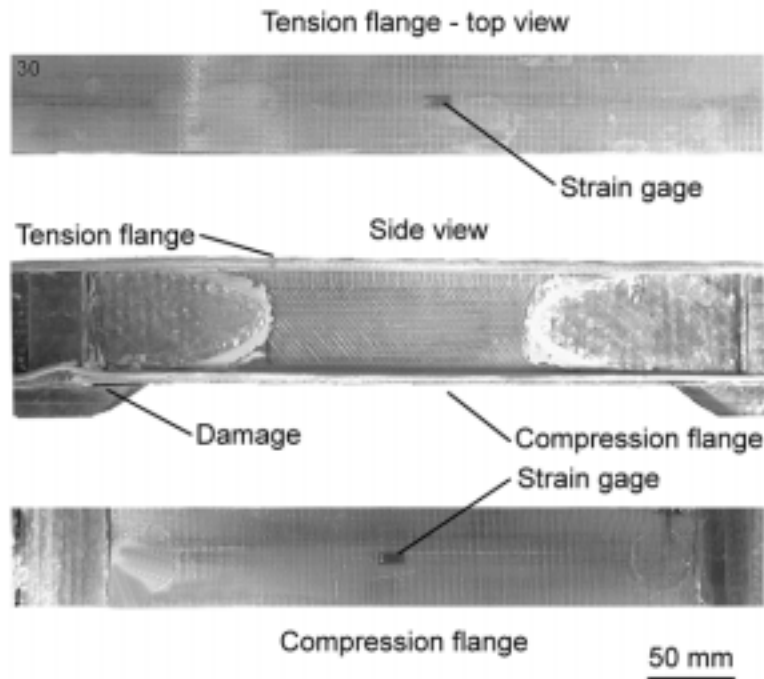
**Figure 98. Beam 30.**

Beam number 30 was fatigued at a rate of 2 Hz under sinusoidal load control with a maximum load of 62.3 kN and a minimum load of 6.2 kN. The maximum load produced an initial maximum tension flange strain of 1.20% and a minimum compression flange strain of -1.05%. The initial beam stiffness was measured as 4,345 kN/m. The beam had four acoustic emission sensors on the flanges: two on the tension flange centered at  $x = 64$  and 533 mm, and two on the compression flange centered at  $x = 178$  and 432 mm. After 5,741 cycles, the test was stopped as the failure mode was identical to Beam number 26. The shear stiffeners had delaminated and the compression flange had a shear failure through its thickness at  $x = 120$  mm, under a compression flange load pad. The shear stiffener had a crack at  $x = 120$  mm, which was the start of the stiffener taper, 30 mm up towards the tension flange. The compression flange had a few transverse tension cracks. The tension flange had started to delaminate over the shear stiffeners. No torsional stiffener or other tension flange damage or delaminations were visible. The failed beam is shown in Figures 98 and 99.

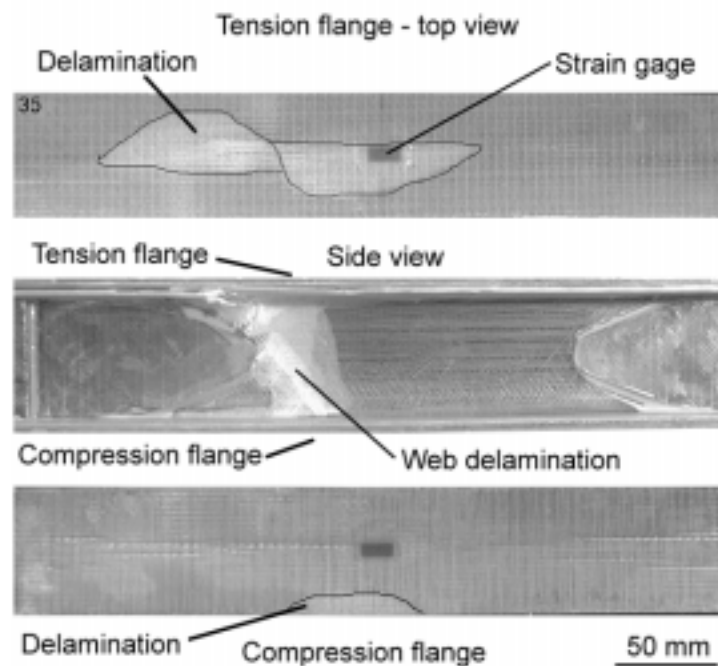
**Figure 107. Beam 35.**

Beam number 35 was fatigued at a rate of 2 Hz under sinusoidal load control with a maximum load of 62.3 kN and a minimum load of 6.3 kN. The maximum load produced an initial maximum tension flange strain of 1.04% and a minimum compression flange strain of -1.02%. The initial beam stiffness was measured as 4,347 kN/m. The compression flange delaminated from  $x = -75$  to 458 mm, after 9,771 cycles. The delamination of the flange caused the web to fail at  $x = 190$  mm with delamination in the web from  $x = 178$  to 267 mm. There were two spot delaminations on the tension flange, caused by the failure, at  $x = 190$  to 356 mm. The failed beam is shown in Figures 107 and 108.

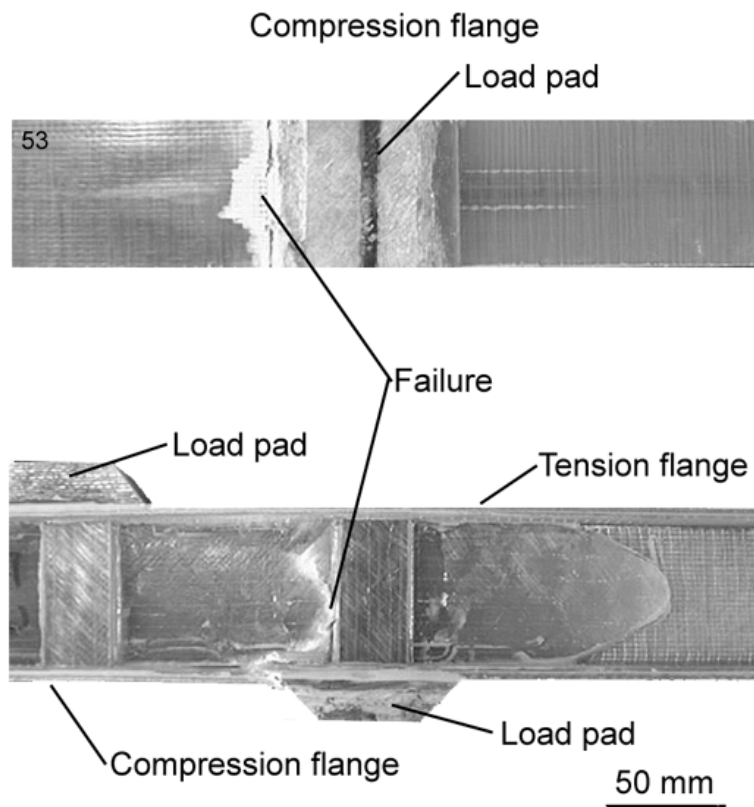
**Figure 112. Beam 53.**

Beam number 53 was fatigued at a rate of 3 Hz under sinusoidal load control with a maximum load of 62.3 kN and a minimum load of 6.2 kN. The maximum load produced an initial maximum tension flange strain of 0.94% and a minimum compression flange strain of -0.89%. The initial beam stiffness was measured as 4,901 kN/m. The beam was stopped after 8,700 cycles due to a shear stiffener and web failure inside the shear loading area of the load pads. This damage is shown in Figure 112. Due to this failure, additional stiffener material was added to the other beams (51, 52 and 54) tested at this or higher loads.

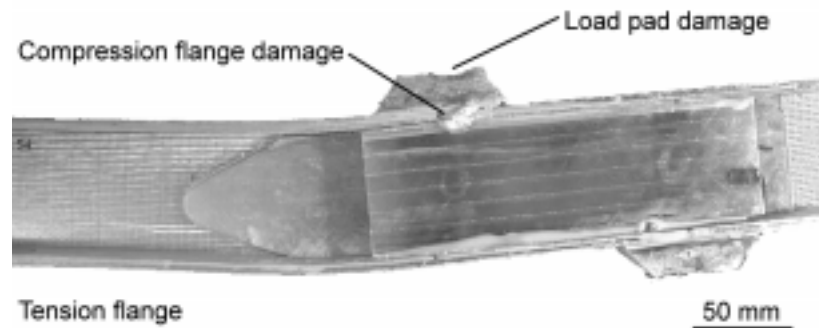
**Figure 113. Beam 54.**

Beam number 54 was fatigued at a rate of 4 Hz under sinusoidal load control with a maximum load of 62.3 kN and a minimum load of 6.2 kN. The maximum load produced an initial maximum tension flange strain of 0.88% and a minimum compression flange strain of -0.88%. The initial beam stiffness was measured as 4,951 kN/m. The compression flange showed no evidence of buckling throughout the test. The beam failed after 2,744,704 cycles with a web and shear stiffener failure shown in Figure 113.

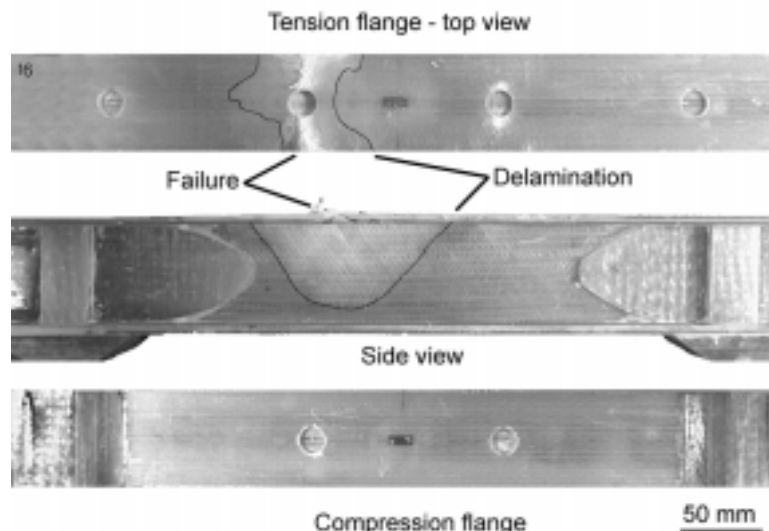
**Figure 116. Beam 16.**

Beam number 16 was fatigued at a rate of 5 Hz under sinusoidal load control with a maximum load of 24.5 kN and a minimum load of 2.5 kN. The maximum load produced an initial maximum tension flange strain of 0.58% and a minimum compression flange strain of -0.53%. The initial beam stiffness was measured as 3,340 kN/m. During the fatigue test, damage started at the outside edges of the holes and continued to grow until failure after 40,448 cycles. The beam failed on the tension flange at  $x = 356 \pm 13$  mm with the underlying delamination between  $x = 325$  to  $x = 394$  mm. This delamination also traveled 25 mm down into the web. Prior to failure, the web had a large number of 1.0 to 1.5 mm long tensile cracks, all located at stitching cross over points. Although these small cracks probably did not have any influence on the failure, it is still disconcerting that every stitch cross-over point on the tension side of the neutral axis had a crack. Some minor delamination damage was present on the tension flange around the holes. No shear stiffener, torsional stiffener damage or delaminations were visible. The failed beam is shown in Figures 116 and 117.
